**GEOTECHNICAL INVESTIGATION FOR:
SANTA CENTRE & MAHALA PARK,
KIMBERLEY,
NORTHERN CAPE PROVINCE**

FINAL REPORT

Report ref No: 19-021

**GEOTECHNICAL INVESTIGATION FOR SANTA CENTRE & MAHALA PARK IN KIMBERLEY, NORTHERN CAPE
PROVINCE**

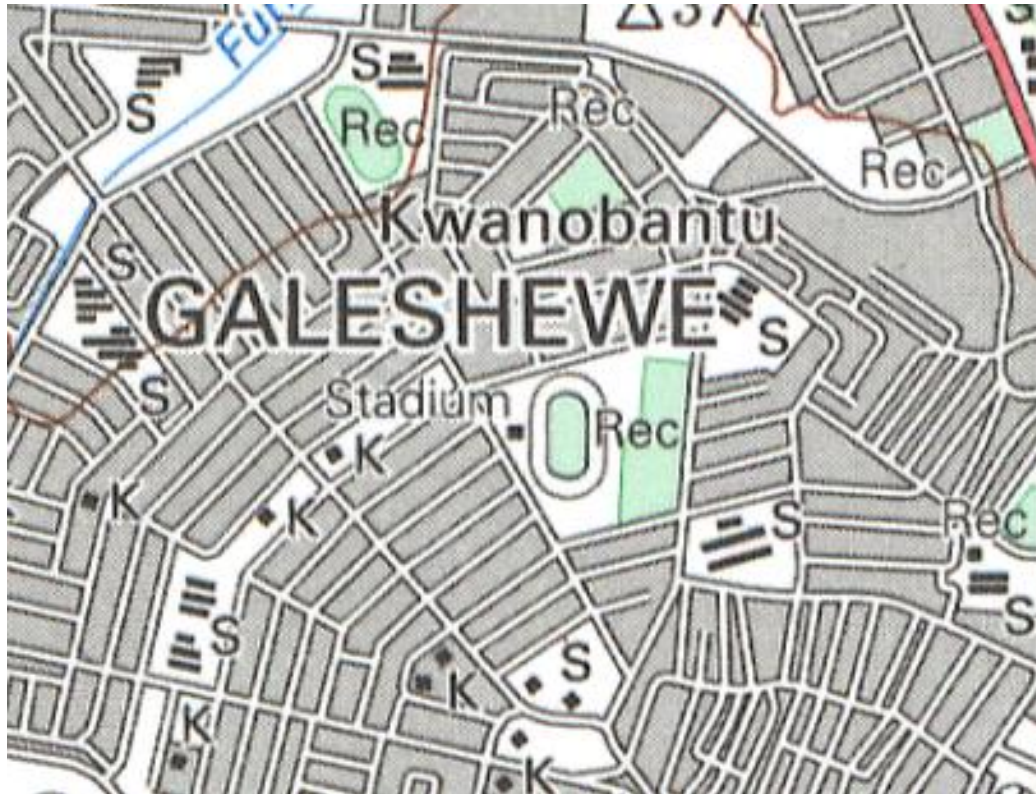
Figure 2 : An extract of a topographic map where the proposed sites are situated

The proposed site is situated on a generally flat terrain. **Figure 2 below** shows a topographical locality map for the study area at scale of 1:50 000 extracted from 2824DA Barkly West. The widely spaced contours lines show the flatness of the terrain.

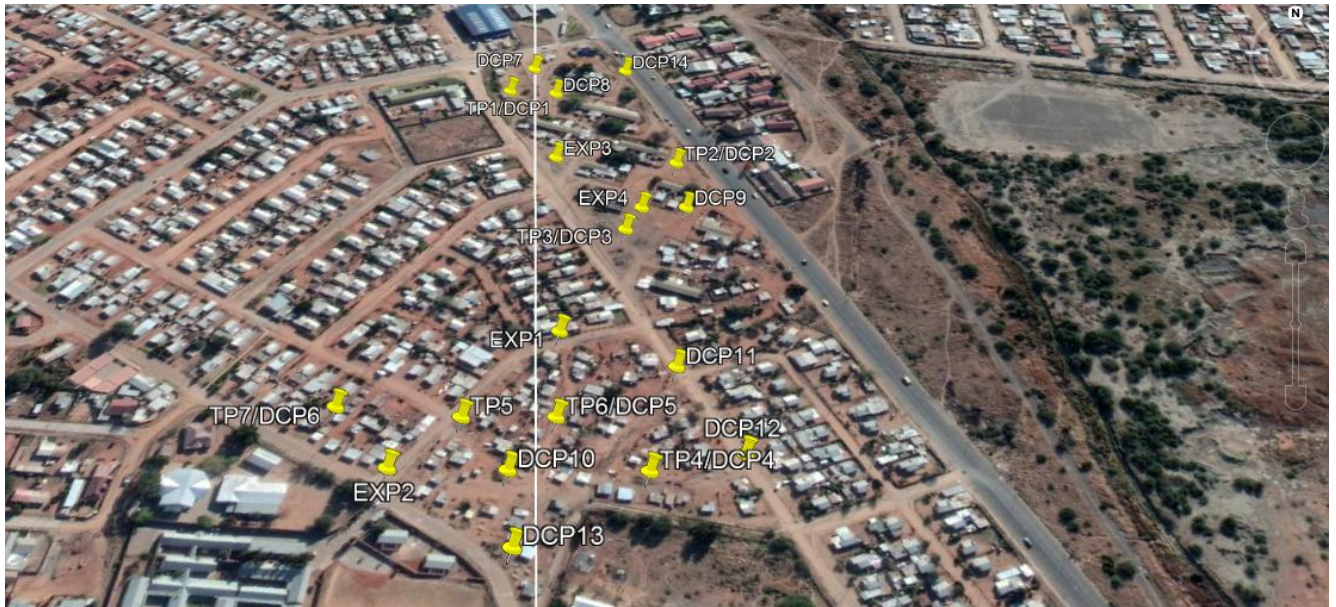
Figure 4: Positions of test pits ,exposures and DCP's pinned on Google Earth image

The positions of the test pits and exposures were recorded using a Garmin GPS handset and are pinned on the Google Earth image on **Figure 4 below**. All areas were profiled by an engineering geologist and their respective photographs are included in **Appendix A** of this report.

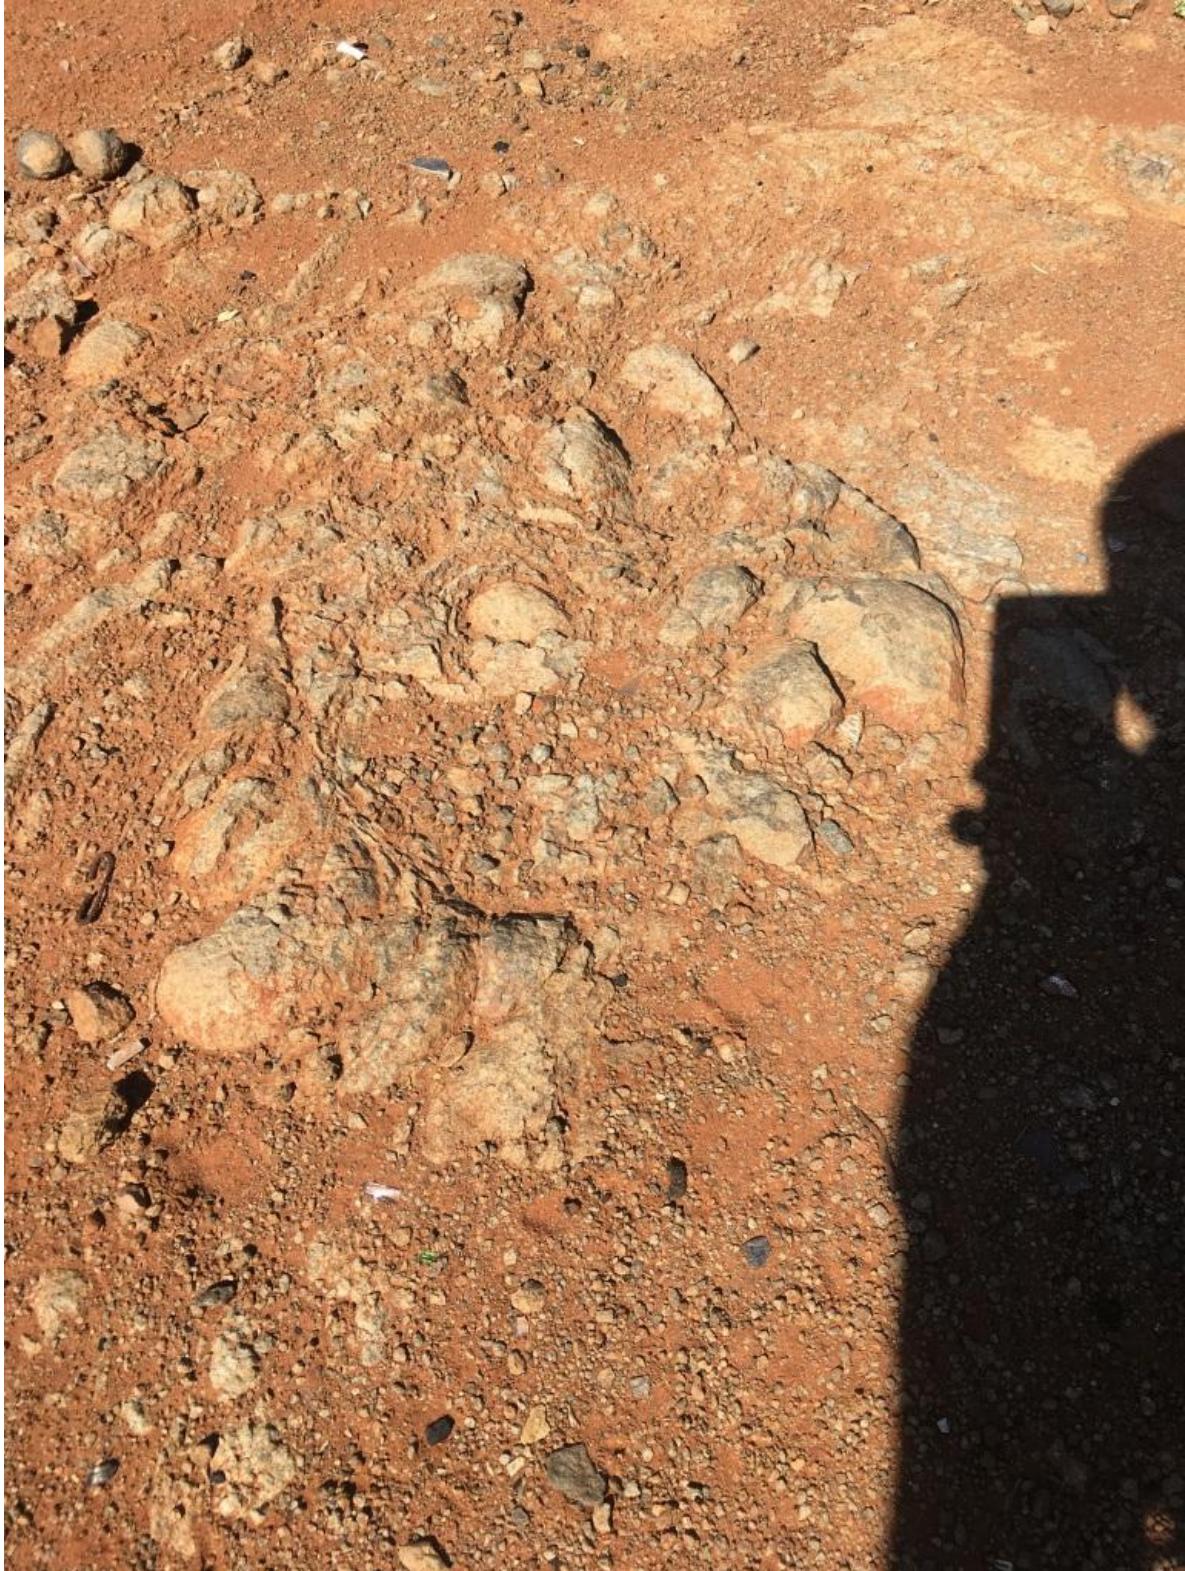
EXP1

CONTRACTOR : MACHINE : TLB DRILLED BY : PROFILED BY : L Phatela TYPE SET BY : L Phatela SETUP FILE : STANDARD.SET	INCLINATION : DIAM : DATE : DATE : 27/1/2020 DATE : 22/02/2020 19:27 TEXT : C:\Kimberly\Santa\Santa.txt	ELEVATION : X-COORD : 2843'03.5"S Y-COORD : 2445'00.4"E HOLE No: EXP 1
---	---	---

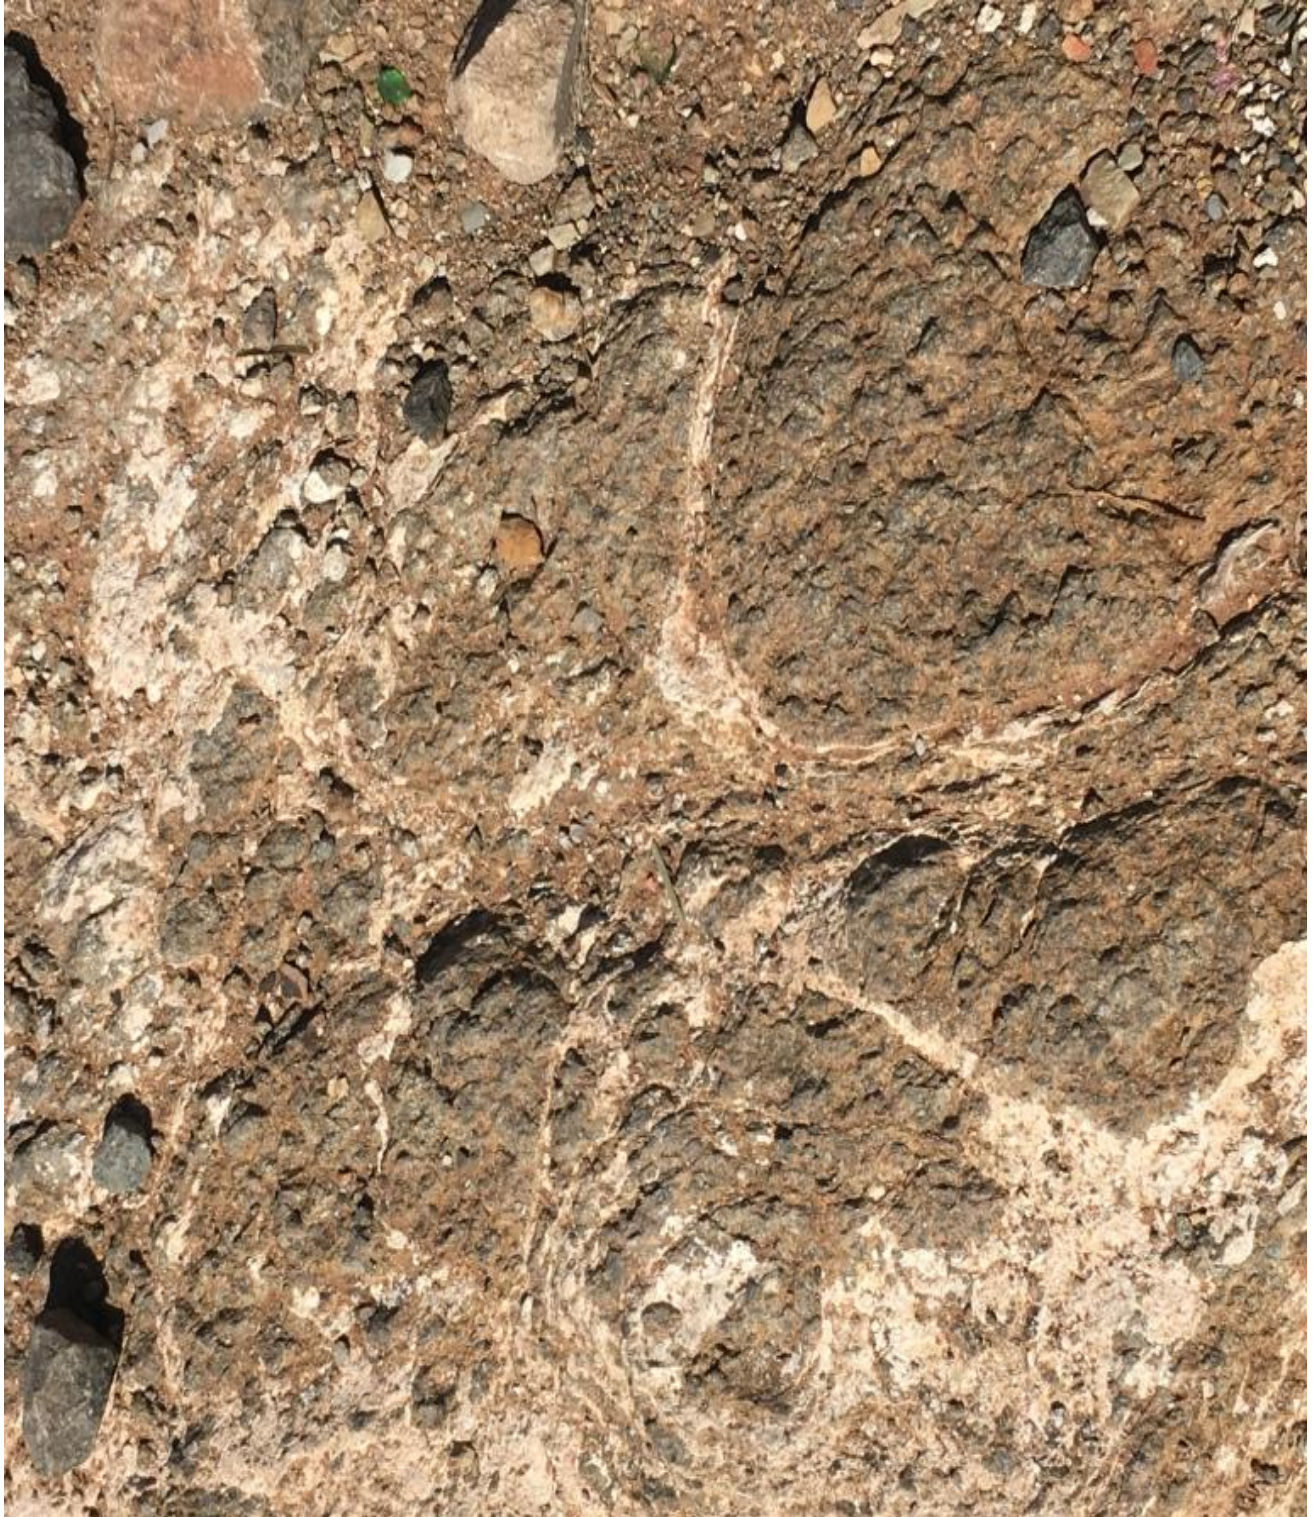
EXP2

0.00 0.10	Dark gray stained orangey brown, highly to medium weathered, closely fractured, soft to hard DOLERITE rock. Jurassic.
NOTES 1) End of exposure on a dolerite bedrock at 0.1m 2) No groundwater seepage 3) No Side wall collapse			
CONTRACTOR : MACHINE : TLB DRILLED BY : PROFILED BY : L Phatela TYPE SET BY : L Phatela SETUP FILE : STANDARD.SET		INCLINATION : DIAM : DATE : 27/1/2020 DATE : 22/02/2020 19:27 TEXT : C:\Kimberly\Santa\Santa.txt	
		ELEVATION : X-COORD : 2843'06.9"S Y-COORD : 2444'57.2"E HOLE No: EXP 2

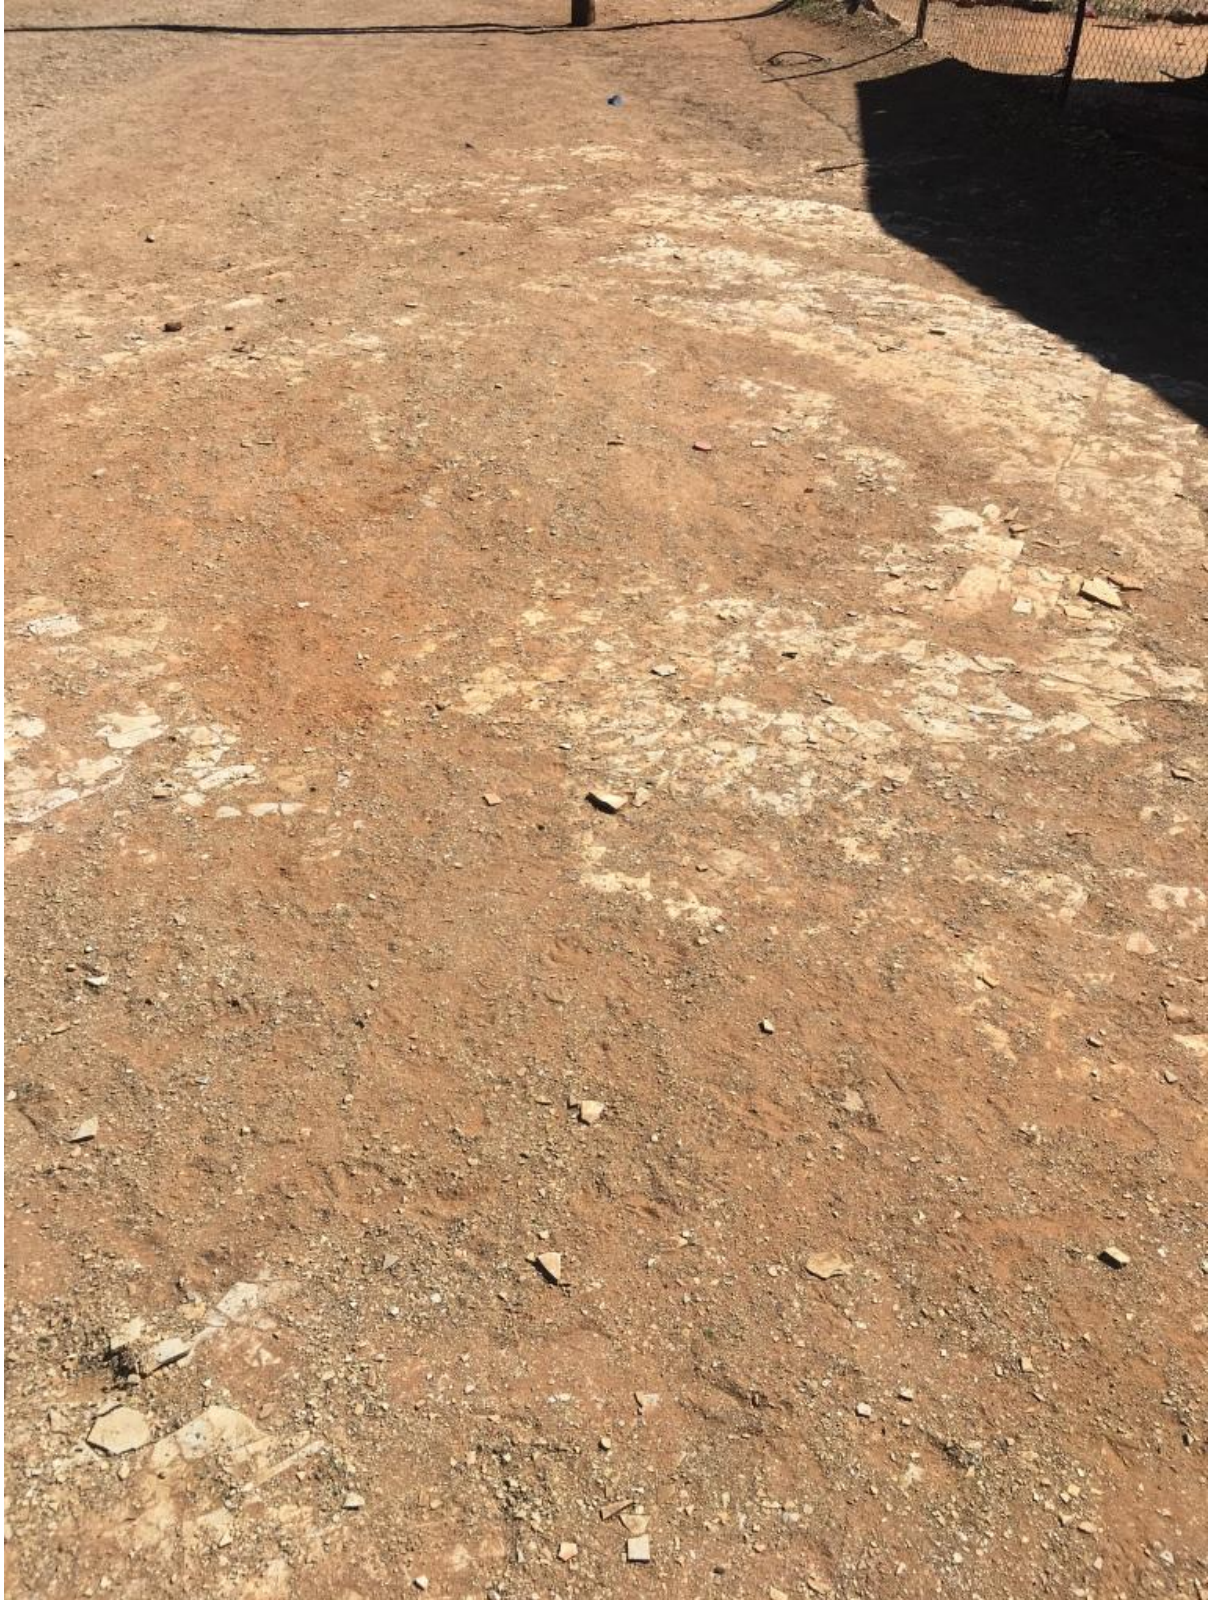
EXP3

Phatela GeoConsulting (Pty) Ltd	KMSD Engineering Consultants Santa Centre and Mahala Park	<div style="border: 1px solid black; padding: 2px; margin-bottom: 5px;">HOLE No: EXP 3 Sheet 1 of 1</div> <div style="border: 1px solid black; padding: 2px;">JOB NUMBER: 19-021</div>			
<div style="display: flex; align-items: center;"><div style="text-align: right; padding-right: 5px;">Scale 1:10</div><div style="border-left: 1px solid black; height: 100px; margin-left: 5px;"></div></div>	<div style="display: flex; align-items: center;"><div style="text-align: right; padding-right: 10px;">0.00 0.10</div><div><p>Greenish gray, slightly weathered, very close to closely fractured, laminated and thinly bedded, medium hard to hard SHALE rock. Ecce Group.</p><p>NOTES</p><ul style="list-style-type: none">1) End of exposure on a shale bedrock at 0.1m2) No groundwater seepage3) No Side wall collapse</div></div>				
<table style="width: 100%; border: none;"><tr><td style="width: 33%; vertical-align: top;">CONTRACTOR : MACHINE : TLB DRILLED BY : PROFILED BY : L Phatela TYPE SET BY : L Phatela SETUP FILE : STANDARD.SET</td><td style="width: 33%; vertical-align: top;">INCLINATION : DIAM : DATE : 27/1/2020 DATE : 22/02/2020 19:27 TEXT : C:\Kimberly\Santa\Santa.txt</td><td style="width: 33%; vertical-align: top;">ELEVATION : X-COORD : 2845'58.1"S Y-COORD : 2445'00.4"E <div style="border: 1px solid black; padding: 2px; text-align: center; margin-top: 10px;">HOLE No: EXP 3</div></td></tr></table>			CONTRACTOR : MACHINE : TLB DRILLED BY : PROFILED BY : L Phatela TYPE SET BY : L Phatela SETUP FILE : STANDARD.SET	INCLINATION : DIAM : DATE : 27/1/2020 DATE : 22/02/2020 19:27 TEXT : C:\Kimberly\Santa\Santa.txt	ELEVATION : X-COORD : 2845'58.1"S Y-COORD : 2445'00.4"E <div style="border: 1px solid black; padding: 2px; text-align: center; margin-top: 10px;">HOLE No: EXP 3</div>
CONTRACTOR : MACHINE : TLB DRILLED BY : PROFILED BY : L Phatela TYPE SET BY : L Phatela SETUP FILE : STANDARD.SET	INCLINATION : DIAM : DATE : 27/1/2020 DATE : 22/02/2020 19:27 TEXT : C:\Kimberly\Santa\Santa.txt	ELEVATION : X-COORD : 2845'58.1"S Y-COORD : 2445'00.4"E <div style="border: 1px solid black; padding: 2px; text-align: center; margin-top: 10px;">HOLE No: EXP 3</div>

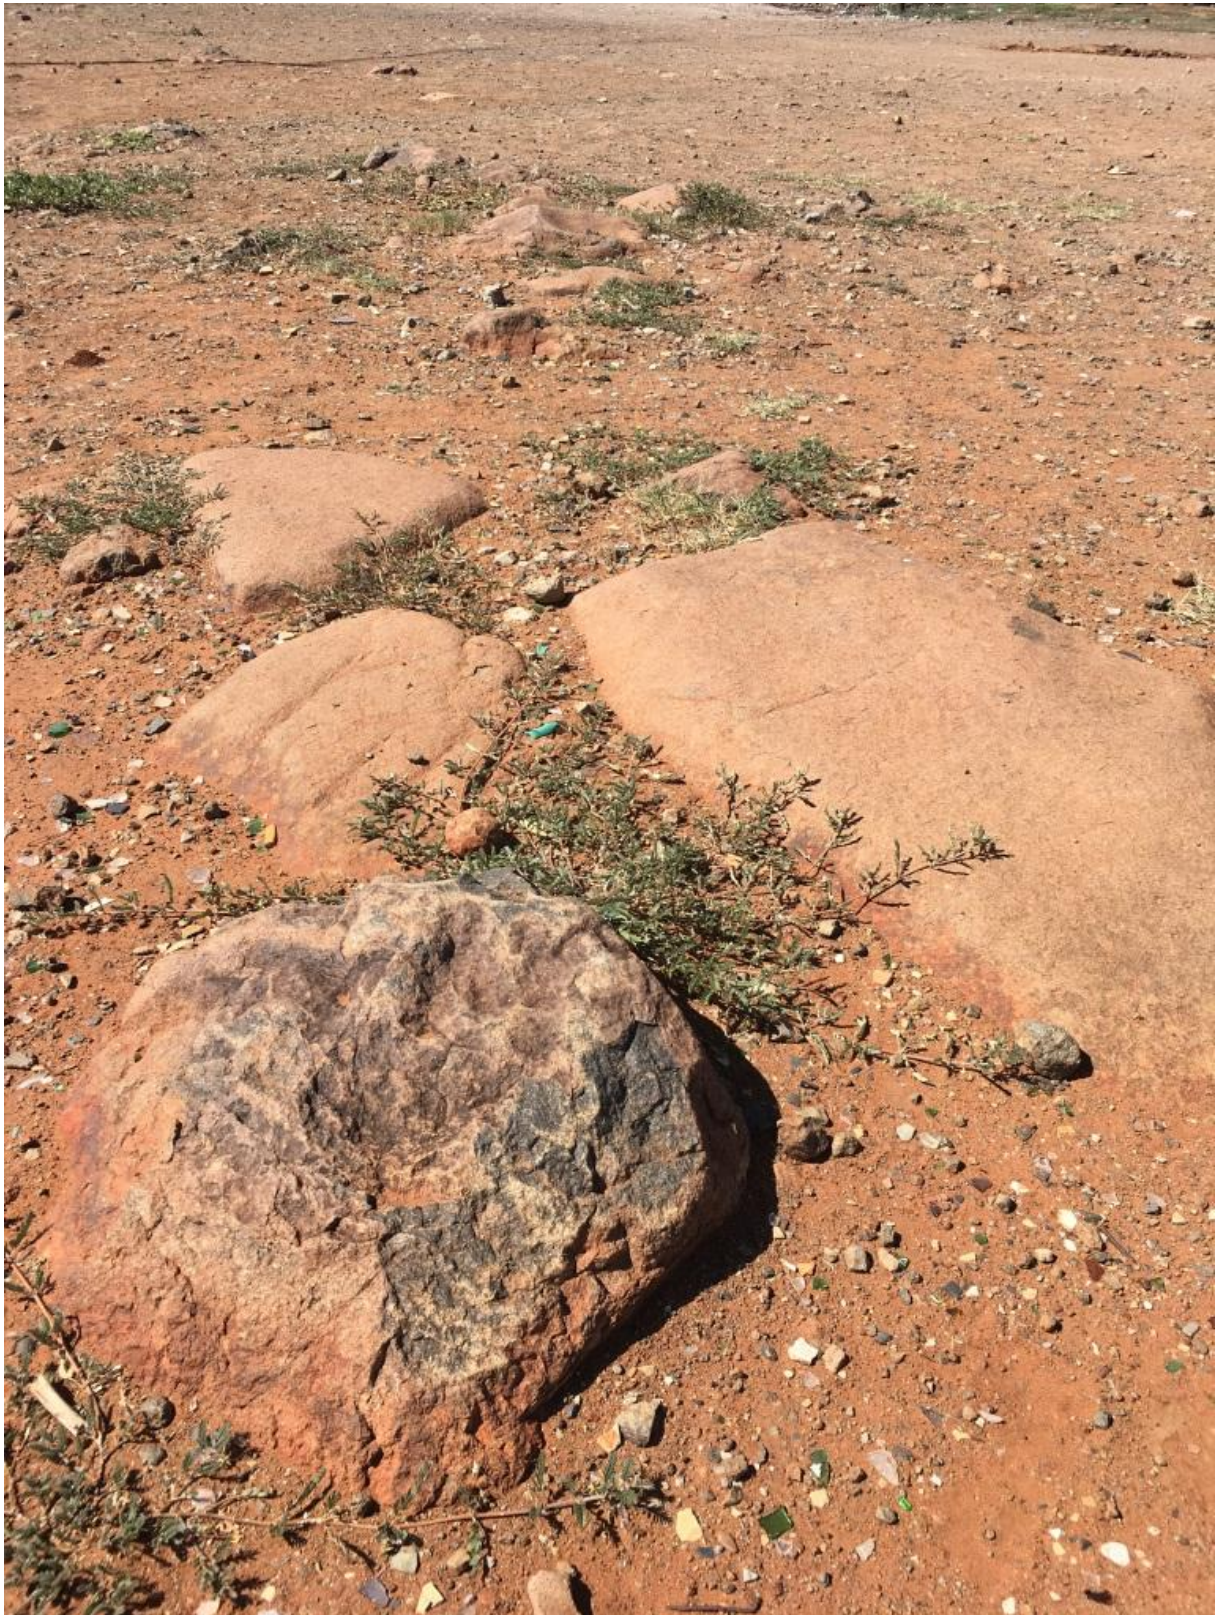
EXP4

0.00 0.10	Dark gray stained orangey brown, highly to medium weathered, closely fractured, soft to hard DOLERITE rock. Jurassic.
NOTES 1) End of exposure on a dolerite bedrock at 0.1m 2) No groundwater seepage 3) No Side wall collapse			
CONTRACTOR : MACHINE : TLB DRILLED BY : PROFILED BY : L Phatela TYPE SET BY : L Phatela SETUP FILE : STANDARD.SET		INCLINATION : DIAM : DATE : DATE : 27/1/2020 DATE : 22/02/2020 19:27 TEXT : C:\Kimberly\Santa\Santa.txt	
		ELEVATION : X-COORD : 2842'59.8"S Y-COORD : 2445'02.3"E HOLE No: EXP 4
